Office: 2 Sales Avenue
Silverdale NSW 2752
Phone/fax: (02) 4774 1017
Mobile: 0419 498 115
Domain: www.mtce.com.au
22 June 2013
REPORT NO: 13-076/1591
ORDER NO: -

EXAMINATION OF ENGINE FAILURE

This report covers the examination of the engine components out of a turbocharged Ford XR6 engine, identified by serial number JGCM8A60735. It is understood that the engine had been reconditioned, was prematurely withdrawn from a tuning facility in Queensland, and was returned by the owner after it made noises.

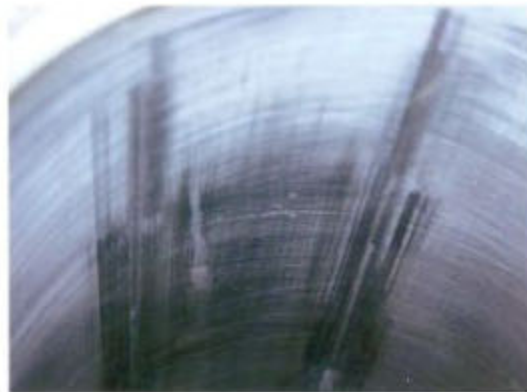
The cylinder bores revealed scuffing on the thrust surfaces. Cylinder #6 revealed the worse scoring and scuffing (figure 1), and was probably the source of the engine noises reported by the owner.

The cylinder bores revealed fresh honing marks. It was confirmed with measuring instruments that the bores were machined to provide a 0.0025" clearance to the pistons. The clearances did agree with the engine builders specification.

Figure 1: The cylinder bore on #6 revealed scuffing and scoring. All of the bores revealed fresh honing marks, indicating that the engine had not been satisfactorily run-in.

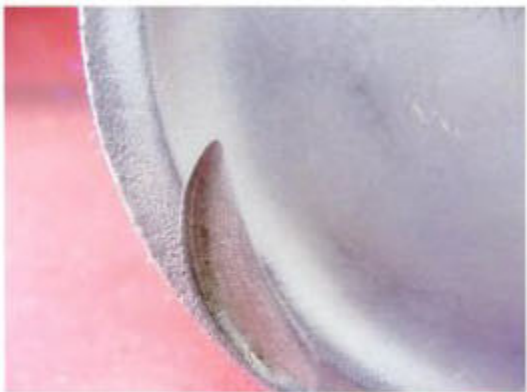
The piston crowns revealed dimpled blast-like patterns in the squish bands and valve pockets indicative of detonation operating conditions (figure 2). There was no evidence of contact of the piston with the valves or combustion chambers.

Detonation is an abnormal combustion process that can be attributed to inadequate octane fuel, early ignition timing, lean air/fuel ratios, and high engine running temperatures.

Figure 2: The #6 piston crown was typical of all the other pistons, and revealed dimpling of the squish bands and valve pockets that was characteristic of detonation.

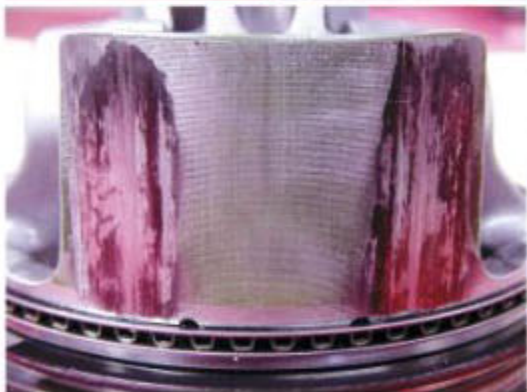
Piston #6 revealed galling and metal flow on the thrust skirt (figure 3), corresponding with the scuffing damage to the cylinder bore. Measurements on the skirt diameter revealed a collapse of the piston, resulting in a piston to bore clearance of 0.011". The cylinder bore diameter remote from the scuffing damage was found to be within tolerance.

The engine revealed evidence of partial seizure of the piston skirts in their cylinder bores. The piston crowns and bearing surfaces of the engine revealed evidence that it was operating under conditions that induced detonation, resulting in high-localised pressures and operating temperatures. The resulting combustion gas blow-by would have resulted in localised breakdown of the lubricant film between the pistons and the cylinder bores, leading to scuffing failure.

Figure 3: The #6 piston revealed severe adhesive wear and galling of the thrust skirt surface. The green solid film lubricant applied by Cosworth (piston manufacturer) had been eroded from the skirt surface. Localised lubricant film breakdown in this area is commonly experienced with excessive blow-by caused by high combustion pressures resulting from detonation.

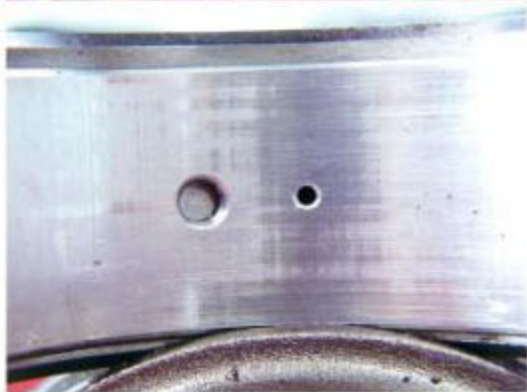
The big-end bearings revealed burnishing at the 12 o'clock position that was indicative of detonation conditions (figure 4). The big-end bearing crush tensions were normal.

Figure 4: The #6 big-end bearing revealed burnishing at the 12 o'clock position that was indicative of detonation operating conditions. There was no evidence of gross lubrication failure evident on the bearing surface.
